Image in cardiology

A Okreglicki

Cardiac Clinic, Groote Schuur Hospital, Cape Town, South Africa

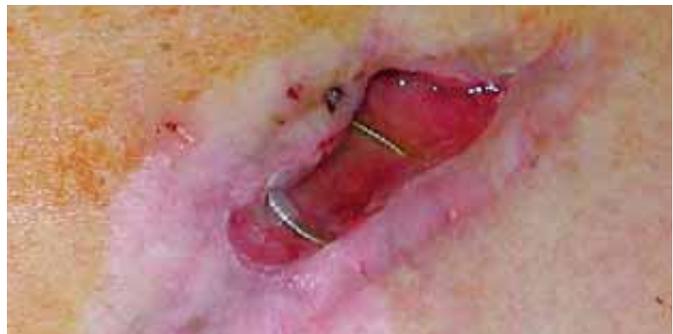
FIGURE 1: The pacemaker wound

A 67-year-old woman was referred with an "oozing" pacemaker wound for an opinion regarding whether the pacemaker pocket was infected. She had her original pacemaker implanted in 1984 and had had a number of pacemaker replacements, the most recent in 2005. She presented 6 months ago to her doctors with rigors, "soaking sweats" and loss of weight of 12kg and was treated for various presumed infections without resolution. A few months later, she noted a discharge from the pacemaker wound. Local wound treatment was given and despite attempts by a surgeon to bury the pacemaker deeper and close the wound, the problem recurred. On examination the pacemaker wound revealed a draining sinus which, after cleaning, showed exposed leads and infected granulation tissue (Figure 1).

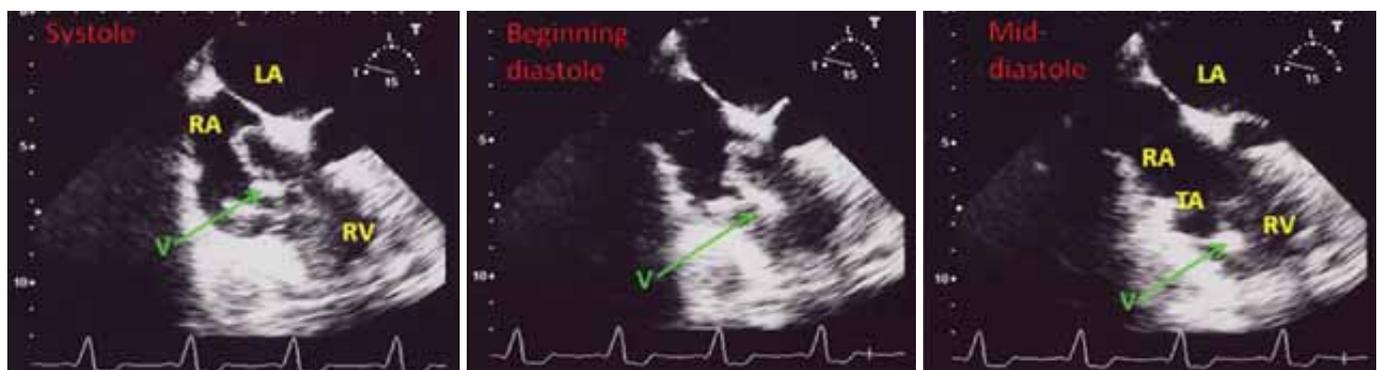
FIGURE 2: The transesophageal echocardiogram in various phases of the cardiac cycle showing the large echobright mobile density, the vegetation (V), which was attached to the pacing lead, prolapsing in and out of the right ventricle (RV). (Abbreviations: RA=Right atrium, LA=Left atrium, TA=Tricuspid annulus)

elongated pedunculated mobile vegetation 0.75 x 3cm attached to the pacing lead and prolapsing in and out of the tricuspid valve. Figure 2 shows the transesophageal images in various phases of the cardiac cycle with the vegetation.
