Image in cardiology

Aneurysm Late after Coarctation Repair

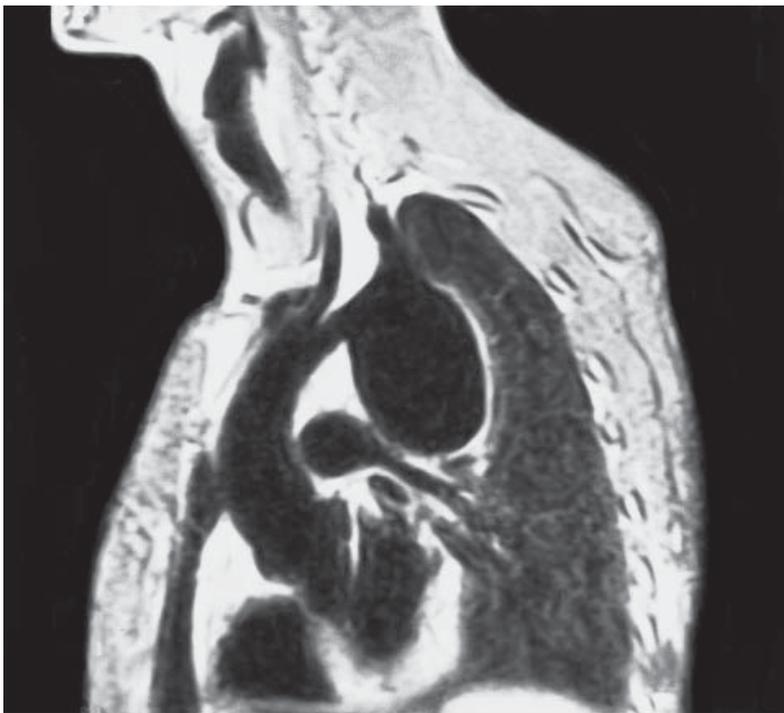
Late complications following repair of coarctation of the aorta include hypertension, residual coarctation, recoarctation and aneurysm formation. This MRI image illustrates an aneurysm at the repair site.

A 20 year old asymptomatic man presented for routine review after repair of coarctation of the aorta using a dacron patch aortoplasty technique. Plain CXR suggested a bulge at the upper left cardiac shadow raising the possibility of aneurysm formation, which was confirmed by MRI. Surgery revealed a very thin walled aneurysm complicating the previous repair site and resection with tube grafting was successful. Late aneurysm formation such as this can complicate up to 50% of Dacron patch aortoplasty repairs, but only rarely complicates end-to-end anastomosis or subclavian flap type repairs. Subjects who have had this procedure should probably have yearly CXR and MRI follow up of any suspicious appearances, and screening MRI every 5 years even if CXR appears normal.
